Group Category: **TC TESTING & CONTROL**Subject: **MASTEC Bin lift Cycle Test – 240 & 140 litre bins**Writer: **PHILIP ALLEN**Authorised by: **DARRIN PRITCHARD**

**TEST 1: 240 LITRE BINS****Introduction**

TEST 2: 140 LITRE BINS**Introduction**

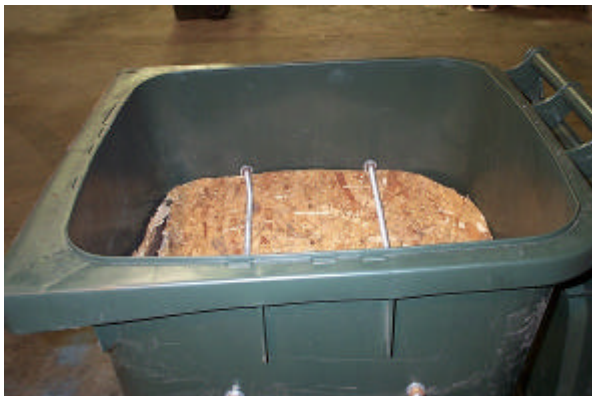
Figure 1

The test bin was loaded with 75 kg of material to a height of 220 mm below the top of the bin. Material in the bin was a combination of hard wood blocks, cardboard & bubble wrap.

The load was secured with two lengths of 9 mm screwed rod retaining a sheet of pine board. As depicted in fig 1.

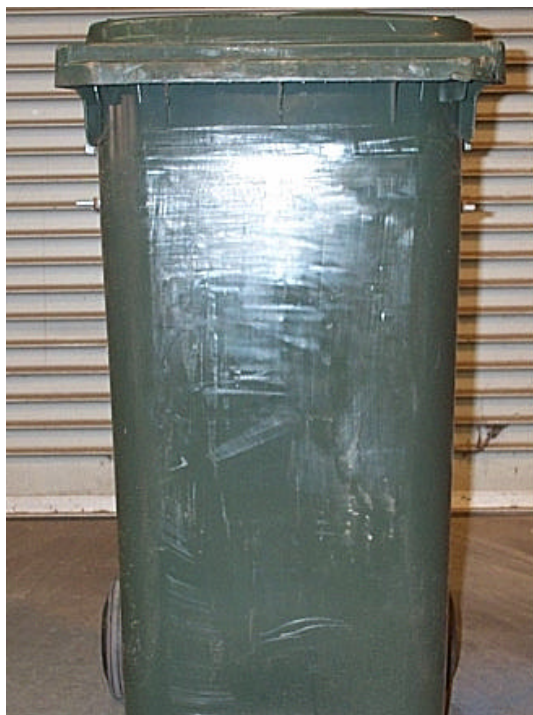
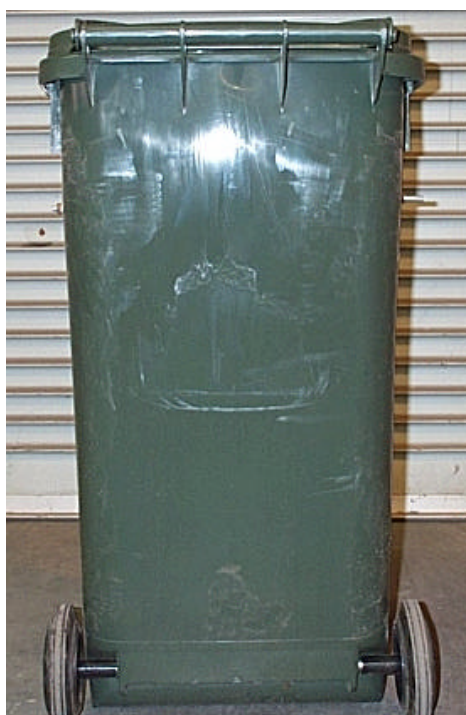
Figure 2 Front view

During the testing the bin was picked up incorrectly positioned in the grab causing the bin lid to contact the hopper. This caused slight distortion to the bin lid and movement of the bin lid hinge pins. This occurred at lift number 302.

As depicted in Figures 2 and 3, the bin was intact and in serviceable condition after testing.

There was no cracking or splitting of the bin in any area, however slight indentations in the bin walls where the grab gripped the bin were apparent.

The test bin indicated that it is more than adequate for operation in conjunction with a lifter, grab and hopper design similar to the MJE Mk IV side loader for a minimum of 500 lift cycles.

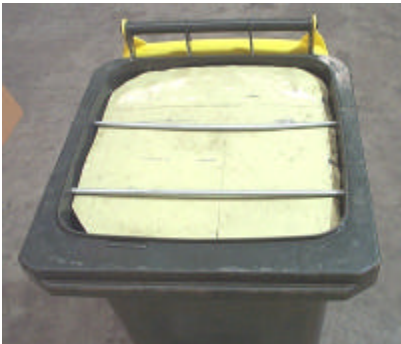
Figure 1

The test bin was loaded with 65 kg of material to the top of the bin. Material in the bin was a combination of hard wood blocks, cardboard & bubble wrap. The load was secured with two lengths of 9 mm screwed rod retaining a steel plate. As depicted in Figure 1.

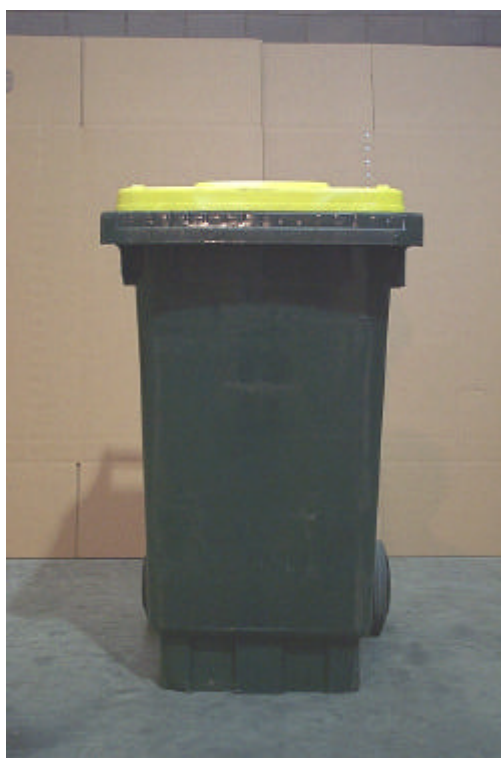
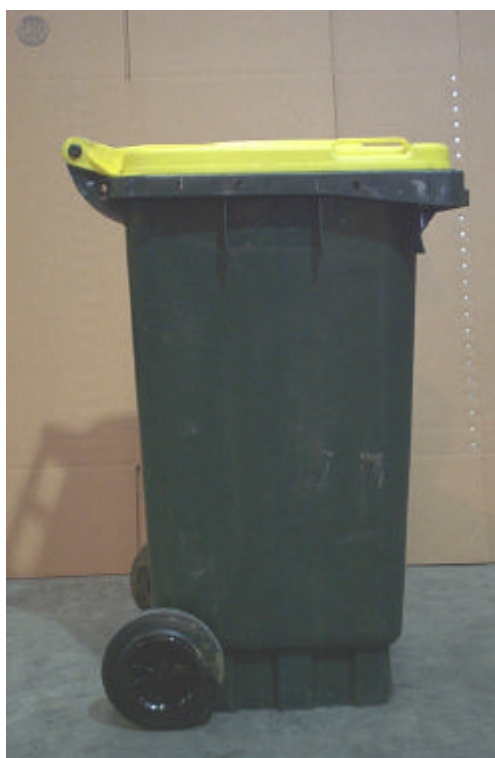
Figure 2 Front View

As depicted in Figures 2 and 3, the bin was intact and in serviceable condition after testing.

There was no cracking or splitting of the bin in any area, however slight indentations in the bin walls where the grab gripped the bin were apparent. Due to the relatively high weight in the bin the unit slipped through the grab and stopped at the bin stacking stops. This caused slight distortion of the stops. No structural damage to the bin.

The test bin indicated that it is more than adequate for operation in conjunction with a lifter, grab and hopper design similar to the MJE Mk IV side loader for a minimum of 500 lift cycles.
